Manhole Inspection Summary

Manhole # S15II2018MH

Insp Date: **10/4/06 8:14 AM**

Location Address: **6116 SMITH AVE**

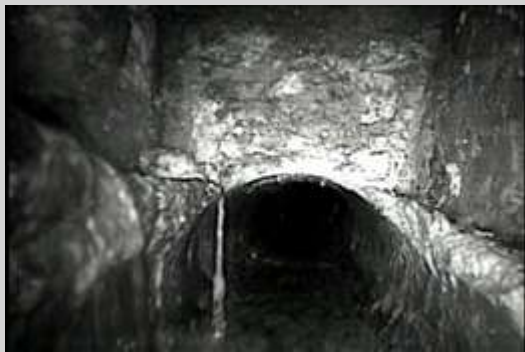
8 in. Circular Gravity Sewer Pipe Out @ 12 O'Clock

Pipe Material: **Clay** ☐ Pipe Lined

Invert Depth: **11.35** (ft.) Flow Characteristics: **Fast**

Infiltration: **None** Pipe Seal Cond: **Unknown**

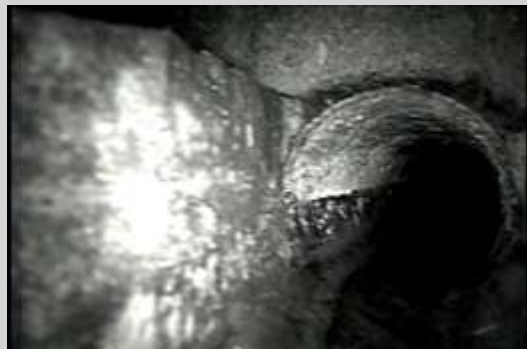
8 in. Circular Gravity Sewer

Pipe Material: **Clay**

Infiltration: **None**
